SUMMARY REPORT

Client: Jack & Jill Buyers
Realtor: Joe Realtor, Dream Team Realty Service
Inspection Address: 123 Inspection Street, Reno, NV 89502
Inspection Date: 4/30/2009 Start: 12:00 pm
Inspected by: Mark F. Rea

CONFIDENTIAL INSPECTION REPORT

123 Inspection Street, Reno, NV 89502

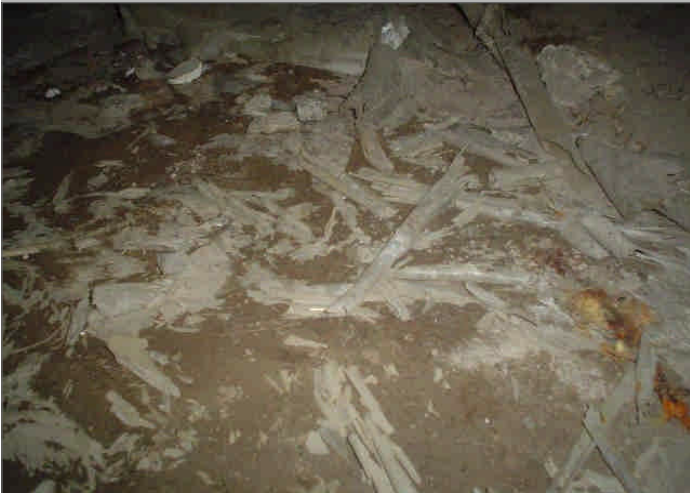
- The existing moisture barrier is deteriorated in various areas within the crawl space and should be replaced for complete ground coverage.

Moisture barrier deteriorated - *Continued*

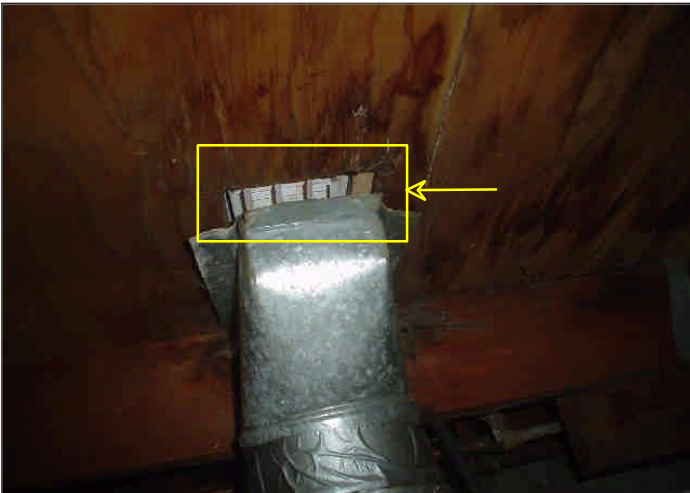
- The heat duct which supplies the guest bathroom is coming loose from the sub-floor and needs to be resecured.

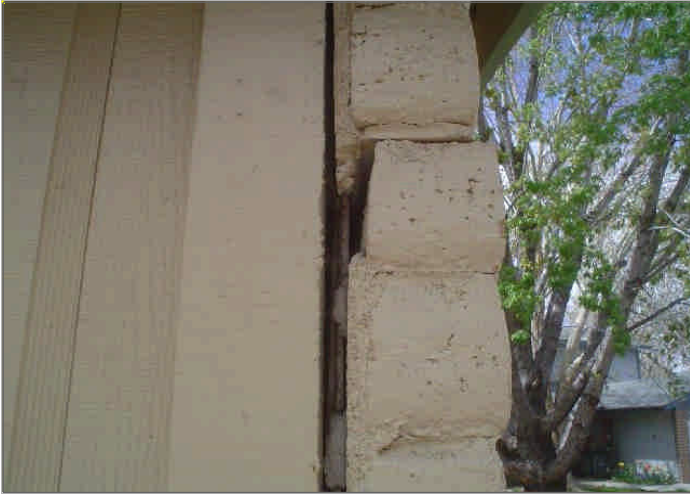
- The brick veneer siding to the left of the garage door is separating from the house, and should be resecured and sealed.

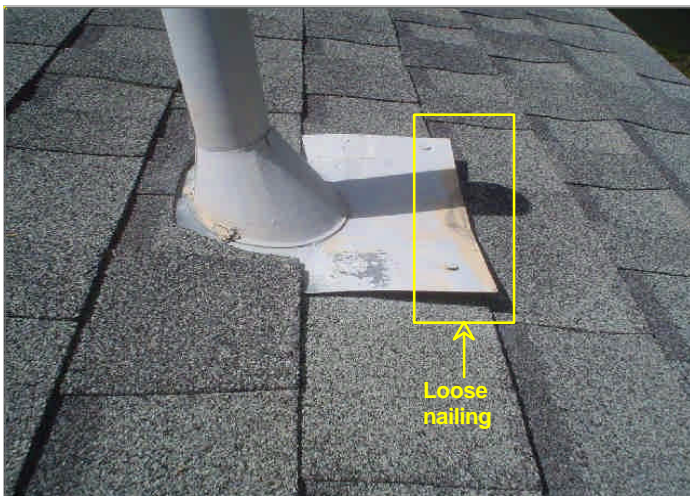
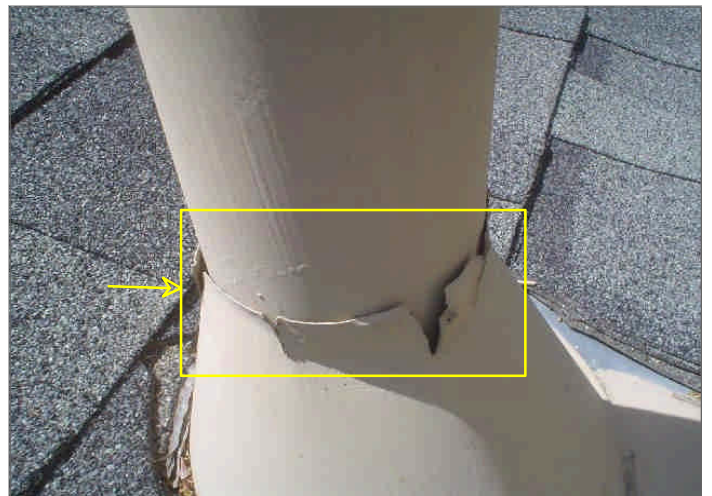
- The flashing around some of the plumbing vents at the roof line are loose, and need to be re-nailed and sealed. Additionally, the storm collars around the furnace flue and plumbing vent by the furnace flue are not properly sealed around the vent pipes, which could allow moisture intrusion to the attic.

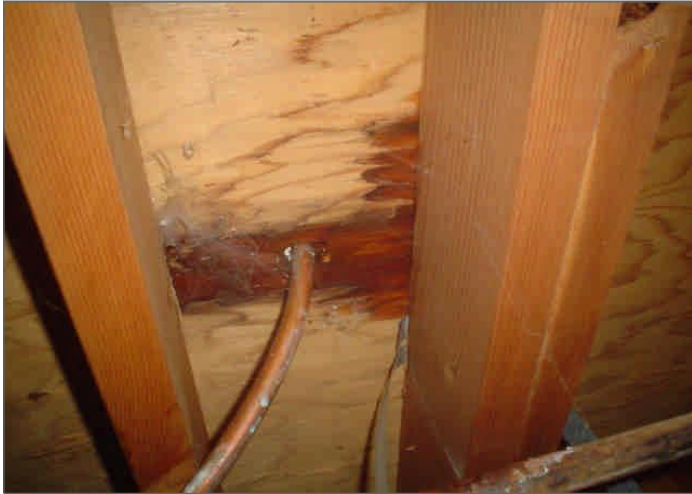
- Water was dripping through the sub-floor in the crawl space area beneath the refrigerator ice maker supply valve, which may be due to a leak at the valve or valve supply plumbing. We tightened the valve faucet at time of inspection, but should be further evaluated by a plumber.

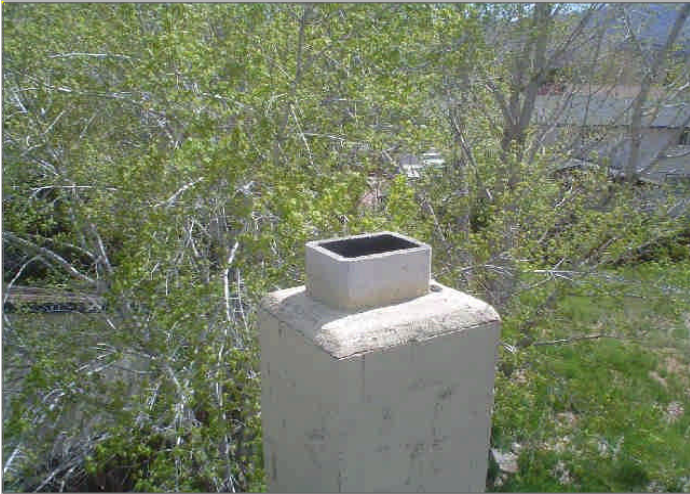
- The fireplace flue is not equipped with a chimney cap, which should be installed for fire safety purposes.

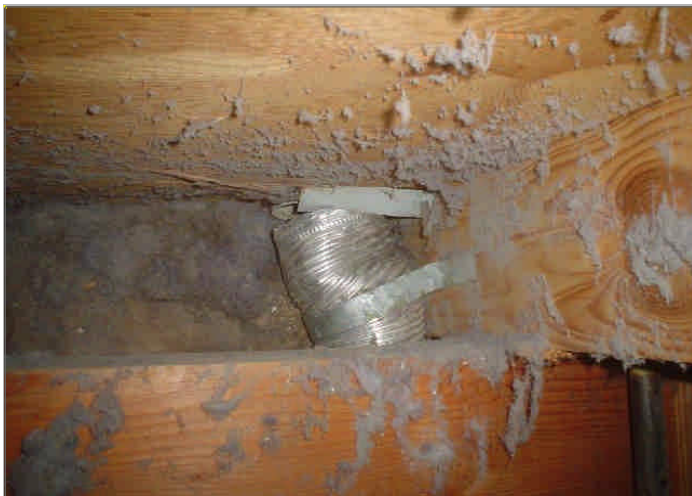
- The dryer vent is separated within the foundation crawl space, at the sub-floor beneath the laundry room, and should be repaired.
