SUMMARY REPORT

Client: Jack & Jill Buyers
Realtor: Joe Realtor, Dream Team Realty Service
Inspection Address: 123 Inspection Street, Reno, NV 89502
Inspection Date: 4/30/2009 Start: 12:00 pm
Inspected by: Mark F. Rea

CONFIDENTIAL INSPECTION REPORT

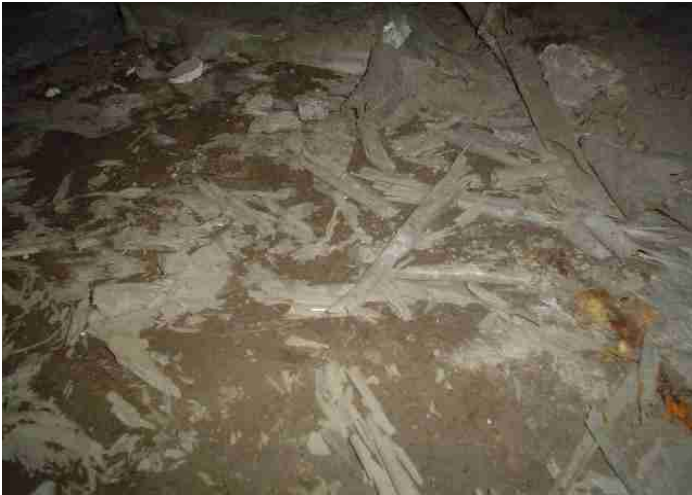
Moisture barrier deteriorated - *Continued*

- The existing moisture barrier is deteriorated in various areas within the crawl space and should be replaced for complete ground coverage.

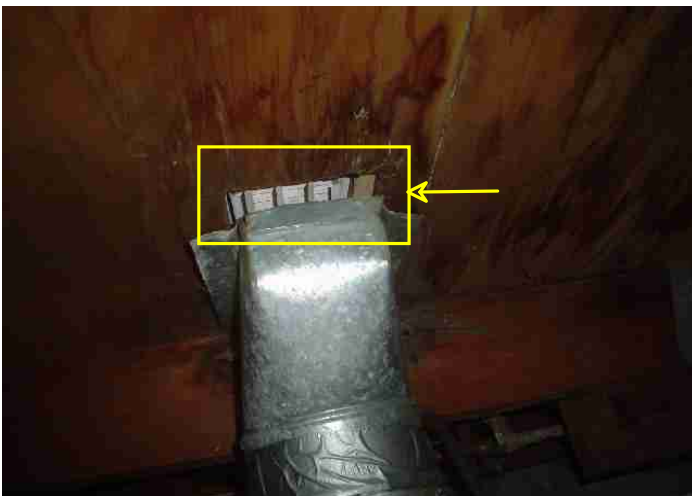
- The heat duct which supplies the guest bathroom is coming loose from the sub-floor and needs to be resecured.

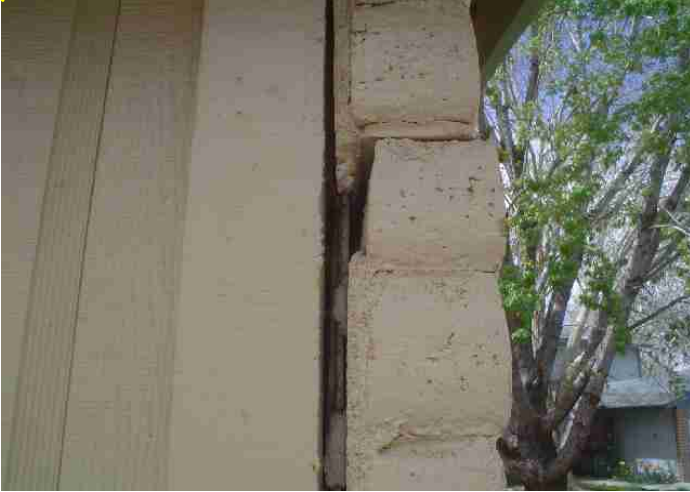
- The brick veneer siding to the left of the garage door is separating from the house, and should be resecured and sealed.

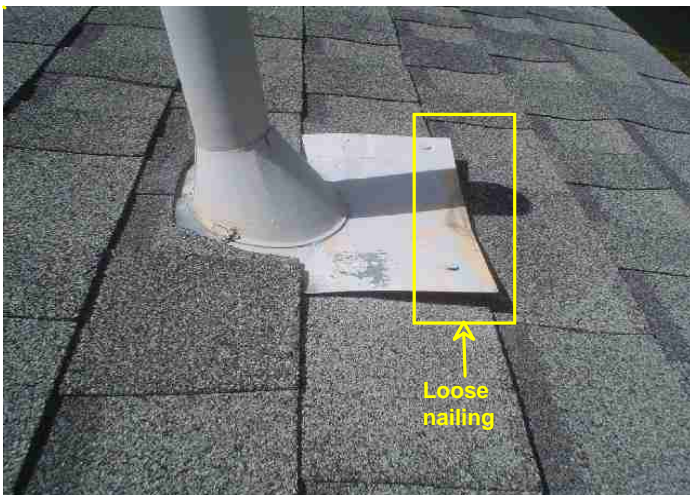
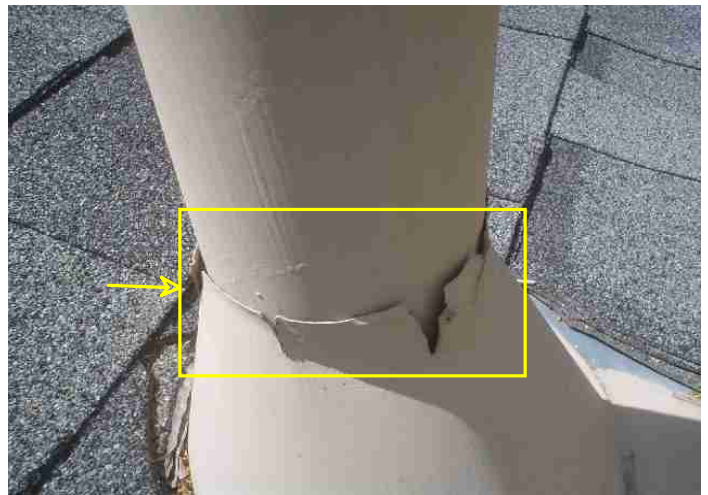
- The flashing around some of the plumbing vents at the roof line are loose, and need to be re-nailed and sealed. Additionally, the storm collars around the furnace flue and plumbing vent by the furnace flue are not properly sealed around the vent pipes, which could allow moisture intrusion to the attic.

The flashing around some of the plumbing vents at the roof line are loose, and need to be re-nailed and sealed. Additionally, the storm collars around the furnace flue and plumbing vent by the furnace flue are not properly sealed around the vent pipes, which could allow moisture intrusion to the attic.

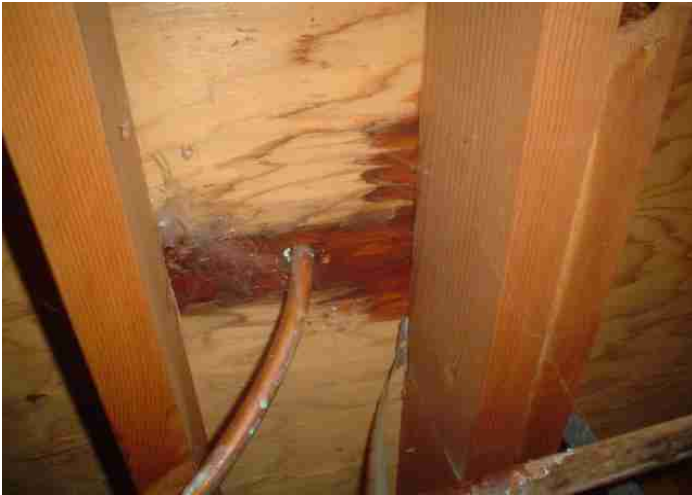
- Water was dripping through the sub-floor in the crawl space area beneath the refrigerator ice maker supply valve, which may be due to a leak at the valve or valve supply plumbing. We tightened the valve faucet at time of inspection, but should be further evaluated by a plumber.

Water was dripping through the sub-floor in the crawl space area beneath the refrigerator ice maker supply valve, which may be due to a leak at the valve or valve supply plumbing. We tightened the valve faucet at time of inspection, but should be further evaluated by a plumber.

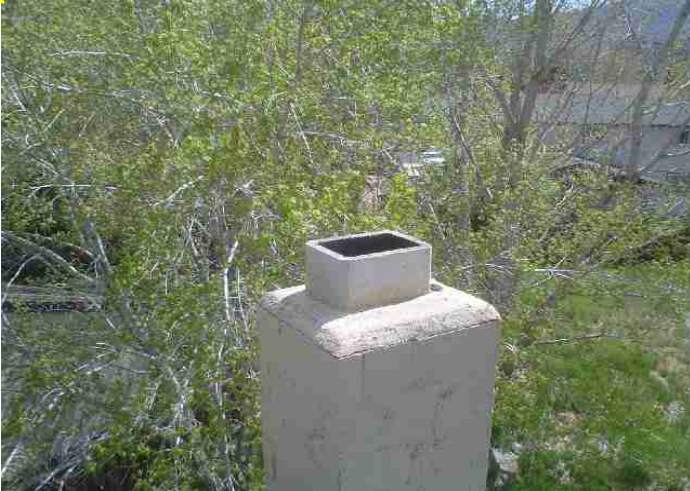
- The fireplace flue is not equipped with a chimney cap, which should be installed for fire safety purposes.

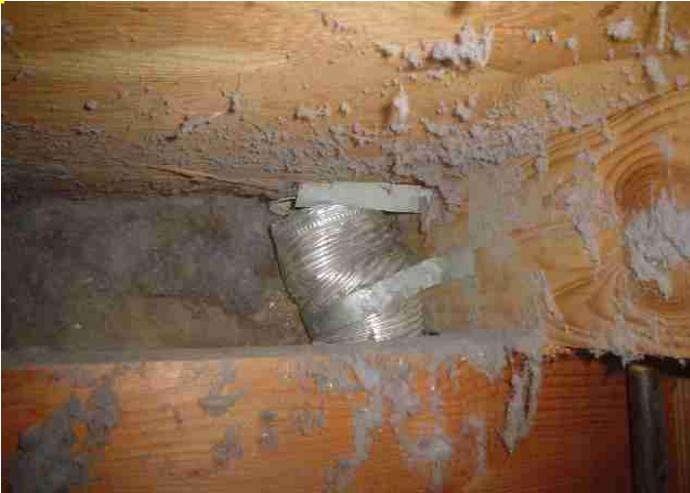
- The dryer vent is separated within the foundation crawl space, at the sub-floor beneath the laundry room, and should be repaired.

The dryer vent is separated within the foundation crawl space, at the sub-floor beneath the laundry room, and should be repaired.
